# Sanitization of an Automatic Reverse-Osmosis Watering System: Removal of a Clinically **Significant Biofilm**

During environmental monitoring of our institution's rodent watering systems, one vivarium was found to have high bacterial loads in the reverse-osmosis (RO) automatic water system. These findings prompted evaluation of the entire RO water production and distribution system. Investigation revealed insufficient rack and RO system sanitization, leading to heavy biofilm accumulation within the system. Approximately 2 wk after discovery in the water system, one of the bacterial organisms isolated in the water supply, Sphingomonas paucimobilis, was isolated from a peritoneal abscess of a severely immunodeficient B6.Cg-Slc11a1r Rag1<sup>im1Mom</sup>/Cwi mouse housed in the same vivarium, suggesting that rodents drinking from this system were being exposed randomly to fragments of biofilm. Plans were developed to sanitize the entire system. Hypercholorination was used first, followed by treatment with a combination of peracetic acid and hydrogen peroxide. Between system sanitizations, a low-level chlorine infusion was added to the system as a biocide. Heterotrophic plate counts

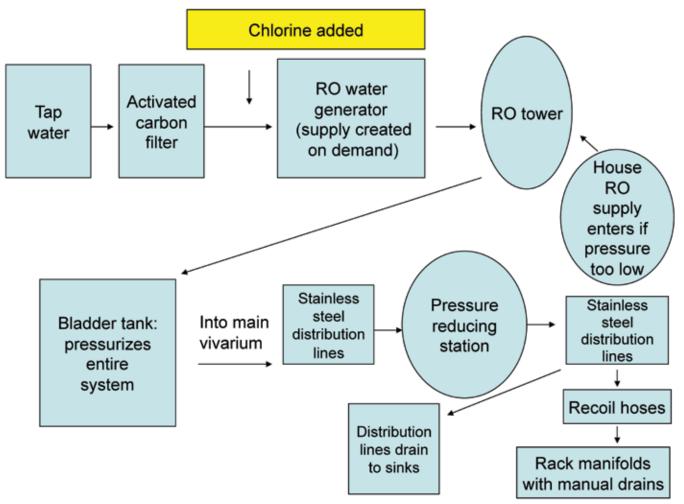
**Figure 1.** Schematic diagram of the automatic water system. The system is a single-pass RO system fed by municipal city water. Water samples were taken at the end of the distribution system, where the distribution lines drain into the sinks in animal holding rooms, and from manual drains on the back of individual rack manifolds. As part of the system sanitization procedures, a low concentration of chlorine (1-4 mg/L) was added to the system as a preventative biocidal agent. Chlorine is added to the water after it passes through the activated-carbon filter but before the water enters the RO membranes of the generator. At the start of the investigation, the back-up house RO, which is activated when water pressure drops, was cultured similarly to other components on the system; yeast, fungal, and bacterial counts all were less than 1 cfu/mL H<sub>2</sub>O.

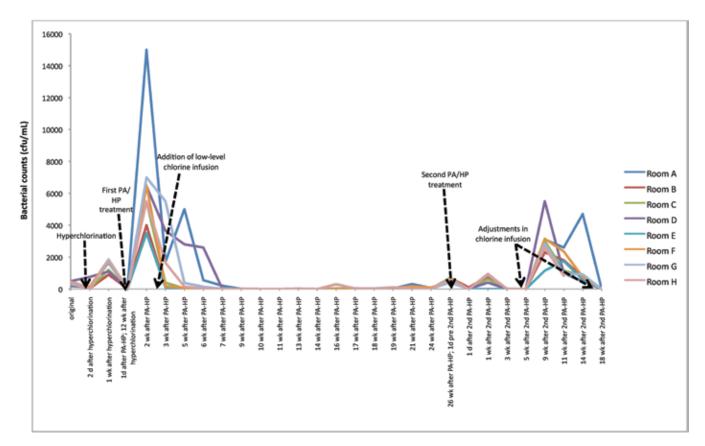
**Figure 2.** Sanitation timeline and bacterial counts at distribution lines. Heterotrophic plate counts were obtained from water samples collected from distribution line drains in 8 housing rooms before and after sanitization with chlorine and peracetic acid–hydrogen peroxide (PA–HP). Yeast and fungal counts both were less than 1 cfu/mL  $H_2O$  for all testing sites at all testing points. Individual sanitization-related events are indicated over the time course.

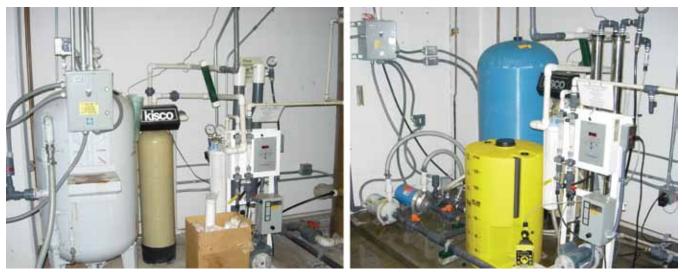
**Figure 3.** Distribution system before (left) and after (right) modifications. The rubber-lined bladder tank on the old system (gray) was replaced by a fiberglass tank (blue). This modification required moving the nearby electrical box. A chlorine tank (yellow) was added to the remodeled system so that this product could be used as a biocide.

previously been used successfully by commercial vendors for RO system sanitization.<sup>18</sup> This compound is incompatible with certain materials such as rubber; therefore prior to its use, the original rubber-lined bladder tank of our system was replaced with a new fiberglass tank (Figure 3). Evaluation of other RO production and distribution system components did not yield additional material incompatibilities with the peracetic acid-hydrogen peroxide compound. The high bacterial plate counts (6681 cfu/mL) that we obtained from multiple testing sites after using this product suggested that it was more effective at disrupting the full thickness of the biofilm, resulting in showers of bacteria that ultimately made their way to the distribution line sample sites.
