Mortality and Morbidity in African Clawed Frogs (*Xenopus laevis*) Associated with Construction Noise and Vibrations

Stephen A Felt,* Andrea M Cowan, Richard Luong, and Sherril L Green

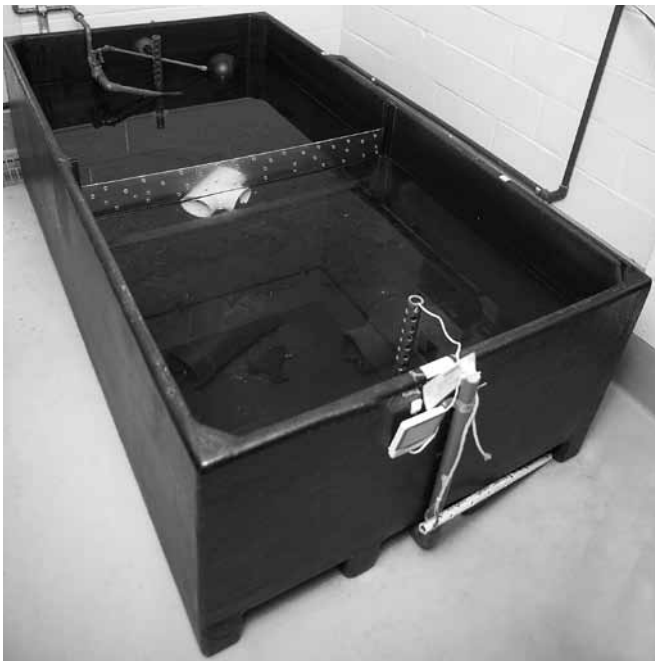
Figure 1. Flow-through 'pond'-style housing system for laboratory *Xenopus*. Image reproduced from reference 7 with permission.

In Spring 2008, 175 adult female *Xenopus laevis* were exposed to construction-related vibrations that caused overt water rippling in the frog tanks. The 3 affected tanks were custom-built static, 300-gal 'pond-style' tanks that sat on the floor of the housing room. The water in the tank developed visible ripples as a result of the vibrations transmitted through the floor during jack-hammering in an adjacent room that was approximately 10 ft away. All frogs in the tanks displayed buoyancy problems, excessive air gulping, and skin sloughing; ultimately 7 frogs died. In addition, these 7 animals were bloated, and 5 of these 7 had regurgitated and everted their stomach and distal esophagus into the oral cavity, resulting in airway obstruction and death. Gross pathologic findings included regurgitation and eversion of the stomach of the distal portion of the esophagus into the oral cavity, obstruction of the airway, and lung overinflation. No significant histologic lesions were observed. Construction vibrations transmitted through the water appeared to have disrupted the mechanoreceptive function of the lateral line system, resulting in overstimulation of the noxious feeding response, regurgitation, and eversion of the stomach and distal esophagus into the oral cavity and subsequent suffocation due to airway obstruction. After immediate cessation of the jack-hammering and relocation of the remaining frogs, no additional morbidities or mortalities occurred.

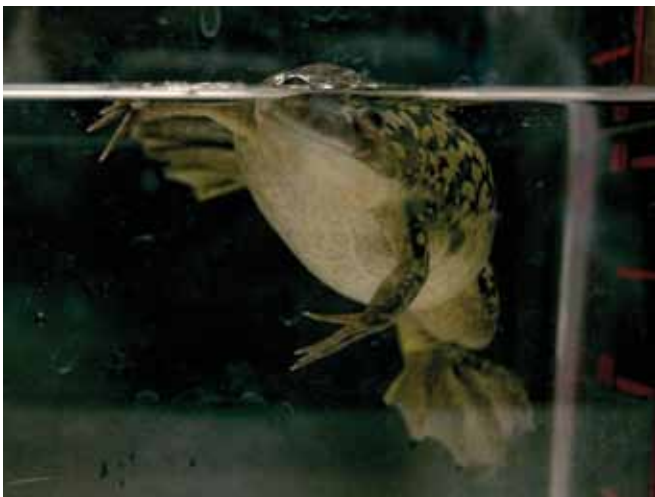
Figure 2. Photograph of an affected *X. laevis* immediately after exposure to construction-generated noise and vibrations. This frog floated on the water surface and was unable to submerge or maintain an upright position (lateral surface floating). Note: the picture does not depict the frog's original housing.

respiratory frequency and the number of frogs rising to the water's surface to gulp air, buoyancy problems (including floating on their sides at the water surface [Figure 2] and inability to submerge), and unexpected death. The jack-hammering that had been initiated approximately 30 min earlier was stopped immediately and the frogs were moved to a temporary housing location in another room approximately 25 ft away. In this location, no surface rippling was observed when jack hammering resumed, and, although audible, the noise of jack-hammering was reduced approximately to the level of an ordinary conversation. Water samples were obtained from the tanks with affected frogs and were tested for standard water quality parameters including total gas pressure, pH, temperature, adjusted conductivity, ammonia, nitrite, nitrate, copper, dissolved oxygen, monochloramine, total chlorine and free chlorine. All values

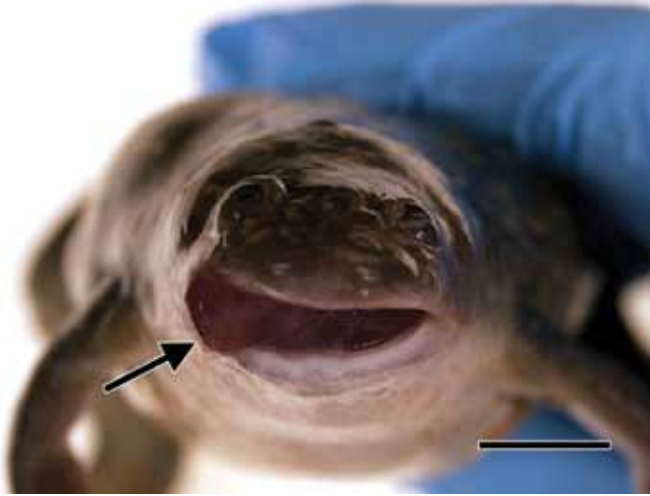
Five dead frogs and 2 live affected frogs were submitted for necropsy. The 2 morbid frogs were unable to submerge and were found floating on their sides (Figure 1); they subsequently were euthanized with tricaine (MS222) according to AVMA guidelines.¹ In 3 of the 5 frogs found dead and in both of the euthanized frogs, gross examination revealed external eversion of the stomach and esophagus such that both were extruding through the oral cavity (Figures 2 and 3). The eversion was severe enough to occlude the airway, resulting in secondary overinflation of the lungs (Figure 4). All other organs and tissues were in normal gross limits in all of the found-dead and euthanized frogs. Microscopic examination was performed on all soft tissues and organs of the 2 euthanized frogs, which in addition revealed multifocal necrosis of pulmonary parenchyma of the overinflated lungs and marked congestion of the everted parts of the stomach and esophagus. The totality of these clinical, gross, and microscopic findings resulted in a final diagnosis of esophageal and gastric eversion–regurgitation secondary to construction-related vibrations.

Figure 3. Photograph of a freshly euthanized *X. laevis* frog submitted to necropsy immediately after exposure to construction-generated vibrations. Note the external presence of everted esophageal and gastric mucosa through the oral cavity (black arrow). Bar, 1 cm.

To our knowledge, this report is the first to describe the transmission of construction-related vibrations through water to result in possible activation of the noxious feeding stimulus via the lateral line system of *Xenopus* and subsequent regurgitation and eversion of the esophagus and stomach into the oral cavity. The lateral line sensory system of *Xenopus* is comprised of hair cell receptors aggregated into neuromast organs, which are found along the sides of the body and around the head and eyes (Figure 5).¹⁸ *Xenopus* use the lateral line to analyze water waves and obtain information about nearby movement in the water as a means of detecting prey.⁶ Because they are indiscriminate feeders, *Xenopus* frogs have evolutionarily developed the unique ability to regurgitate and evert their stomach, expel the contents, and wipe the stomach mucosa free of any accidentally ingested noxious substances. Although studies elucidating the neurophysiology and mechanics of this natural behavior in frogs have not yet been done, chemicals,^{14,15,23} radiation,¹³ and mechanical stimulation⁸ have all been shown to induce this response. In addition, *Xenopus* frogs have been observed to display this behavior when stressed or stimulated too soon after eating.⁷

The stomach regurgitation reported here possibly was due to excessive water vibrations as a result of nearby jack-hammering, resulting in a powerful and prolonged central activation of the noxious feeding stimulus (via overstimulation of the lateral line system). This strong and protracted stimulation associated with construction vibrations may have inhibited the normal stomach retraction mechanism, created a partial airway obstruction, and prevented expulsion of air from the lungs. We also considered an alternate explanation for the stomach regurgitation—exposure to toxic substances—but this cause seemed unlikely, given that frogs had not been fed during the 48 h prior to the problem, were maintained in a secure location, lived in water that was verified to be of appropriate quality based on laboratory testing, and lacked lesions in liver, kidney, or nervous tissues—targets of many toxins. The underlying pathogenesis of the skin sloughing (for example, excessive exfoliated skin in water) remains uncharacterized, but possibilities include traumatic injuries, an underlying dermatopathy, and partial anorexia, because healthy frogs ingest dead skin.⁷ A leading cause of acute death and buoyancy disturbances in *Xenopus*—supersaturation of

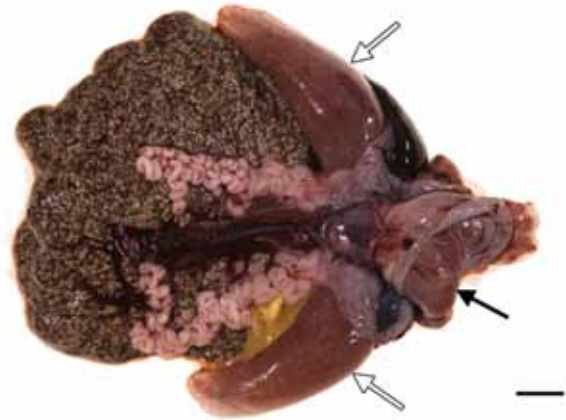
Figure 4. Gross photograph of an organ pluck from a euthanized *X. laevis* frog submitted to necropsy immediately after exposure to construction-generated vibrations. Note the presence of everted esophageal and gastric mucosa (black arrow) and overinflated lungs (white arrows). Bar, 1 cm.

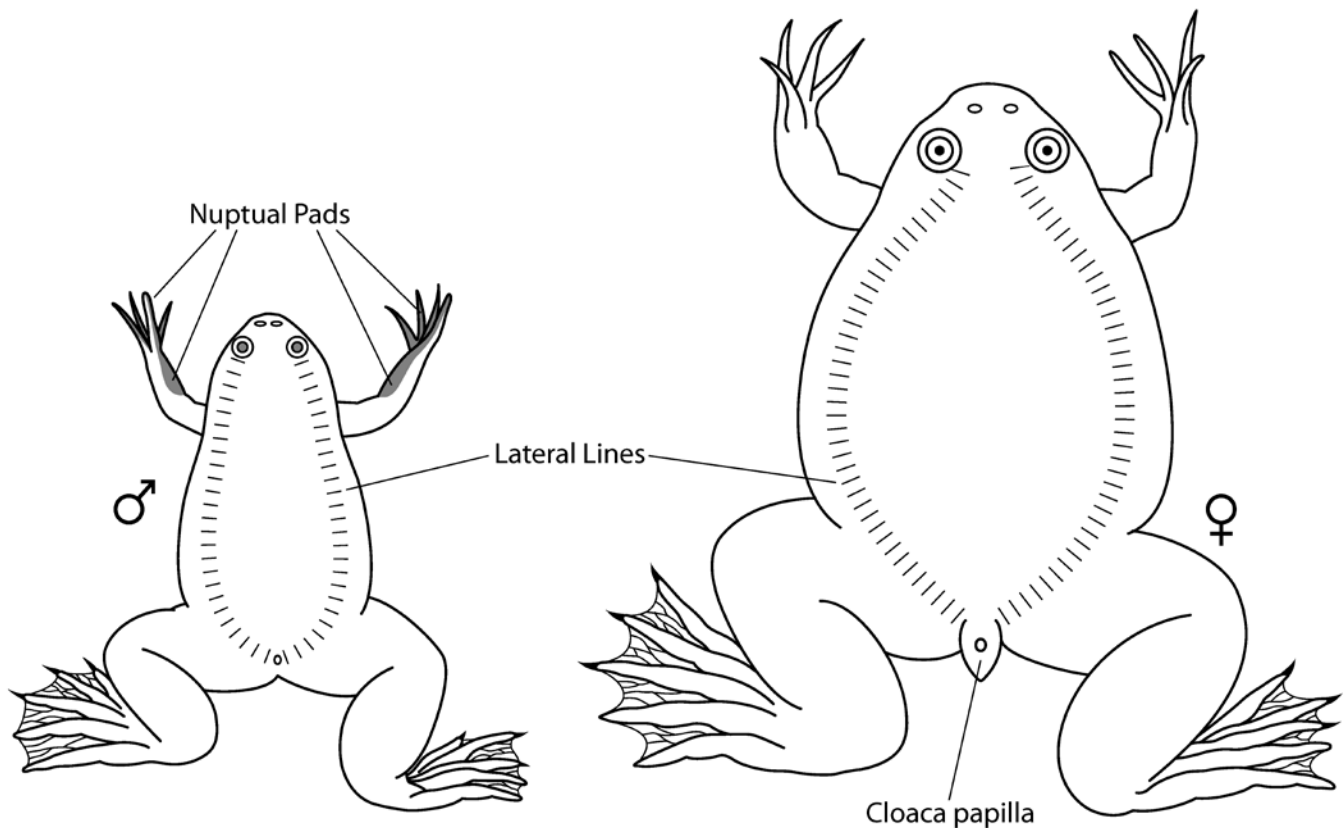
Figure 5. The hatch marks represent a portion of the lateral line system in *Xenopus*. The lateral line system is composed of rows of hair cells, a portion of which function as mechanoreceptors that respond to water movement and vibrations. Image reproduced from reference 7 with permission.
